North American Society for Trenchless Technology (NASTT)
2023 No-Dig Show
Portland, Oregon
April 30 – May 4, 2023

TM-T6-04

Simplifying Force Main Inspections with New Inline Tool

Patrick Hulsebosch, P.E., RJN Group, Inc., Downers Grove, IL
Yann Gallin, RJN Group, Inc., Downers Grove, IL

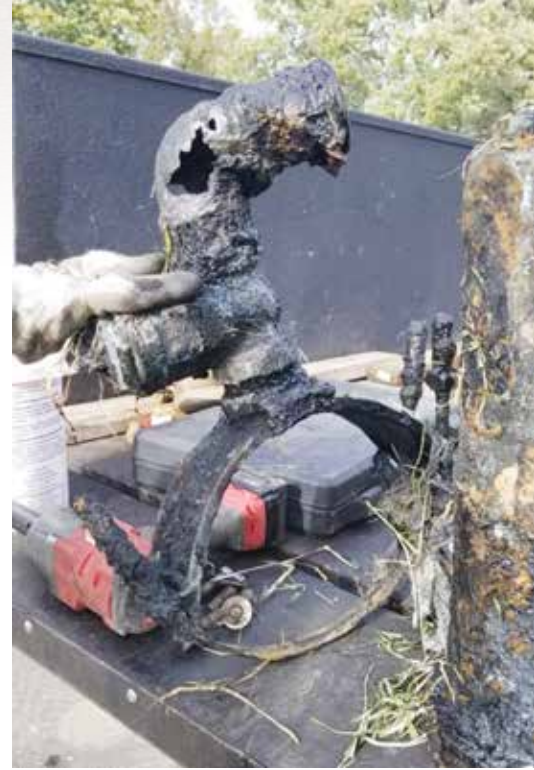
Figure 2: Broken Air Release Valve due to H_2S Damage

As seen in Figure 2, if not properly maintained, these structures can be the source of failure on a force main. For example, the ARV in Figure 2 was on a PVC force main but a local stream had submerged the structure with infiltration. As a result, the ARV became inoperable and sulfide corrosion slowly deteriorated the metallic piping and valve. In the end, one of few only metallic components of the entire PVC force main was the source of the failure.

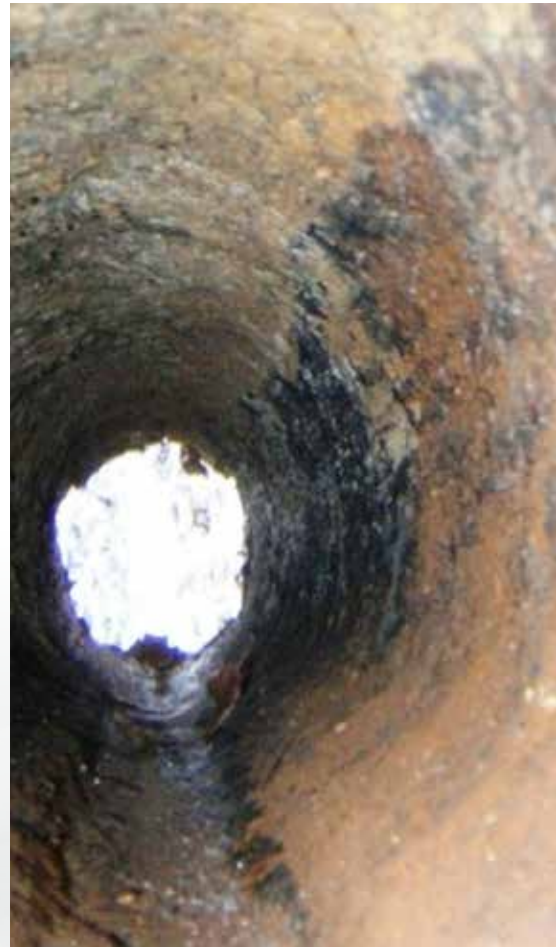
abrasion of the pipe's invert as seen in Figure 3. Conversely, a stationary bed reduces the cross-sectional area available in the pipe effectively reducing the hydraulic capacity. Both types of solid deposits can cause long-term force main problems to occur if left unaddressed. Finally, gas pocket formation is more likely to occur in slower velocities.

Figure 3: Pipe Invert Abrasion

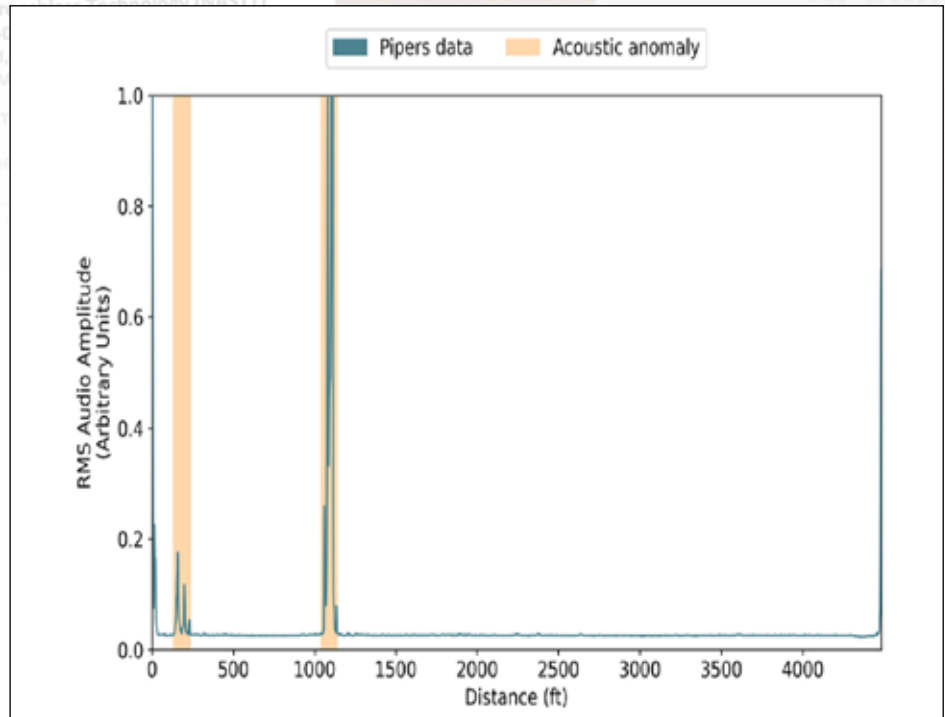
Figure 5: Acoustic Amplitude Analysis

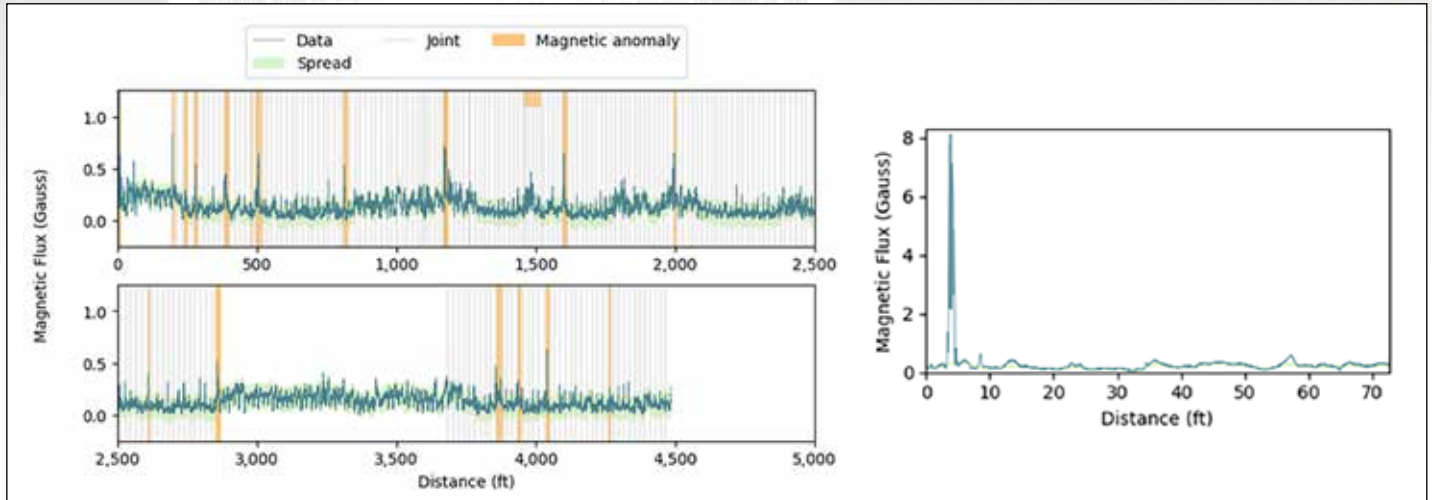
Figure 6: Magnetic Flux Analysis (Left); Flow Meter Identified as Anomaly (Right)

The last set of data collected during SLAs is the magnetic flux analysis. The magnetic flux can provide insights along the pipeline and is intended to identify bends, areas of potential deterioration, material changes, air release valves, flow meters, cleanout structures, and additional metallic fittings along the force main. As seen in Figure 6, magnetic anomalies are identified where spikes occur between joints. The gray bands represent joints, the green band indicates the

characteristic spread in the magnetic flux, and the orange highlights indicate magnetic outliers that fall outside the characteristic spread. As an overall condition assessment, pipelines with wider spread in the magnetic flux are expected to be in worse condition compared to those with narrower spread and smoother magnetic flux. Magnetic flux data should be plotted along the profile of a force main to determine if any large anomalies occur at high-risk locations or locations where an acoustic anomaly was located. Similarly, to acoustic anomalies, the size of the force main should dictate whether rehabilitation or further inspection is warranted for a magnetic flux anomaly. Large magnetic anomalies located at high-risk locations in larger diameter metallic pipes should be further inspected in a second phase. Conversely, replacement may be a more feasible option on smaller diameter force mains.

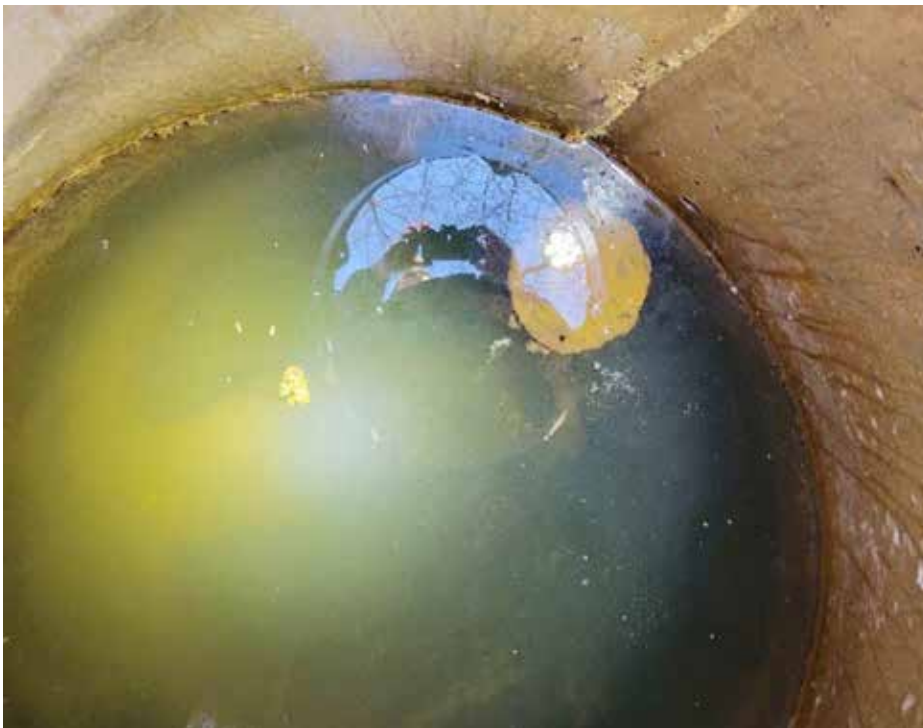
Figure 7: Submerged Air Release Valve

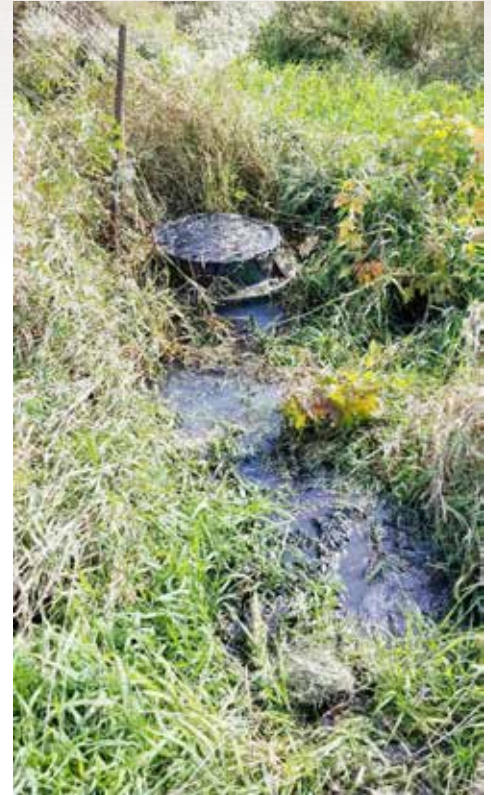
Figure 8: October 2022 ARV #1 Break

In October 2022, the Valley Force Main suffered a break at the first ARV along its line. As seen in Figure 8, the failure occurred at the ARV piping where corrosion had caused severe wall loss. The Authority was proactive in its inspection but it is difficult to estimate the true remaining life of the pipeline if no rehabilitation were to occur. A break or leak could be months or years away. Being proactive for force main maintenance, rather than reactive, is highly recommended when considering a budget. An emergency force main repair can be incredibly expensive.
